Joint Network Secretariat  
Normal Procedure Task Force  
**Broken wheels**

**Final output**

In 2016/2017 broken and cracked wheels BA 314 / ZDB29 (with a slope under the wheel flange) and BA004 in some applications in the European rail freight business occurred. To mitigate the risk on 28th July 2017 short term measures in operation, wagon maintenance and off vehicle wheelset maintenance were disseminated.

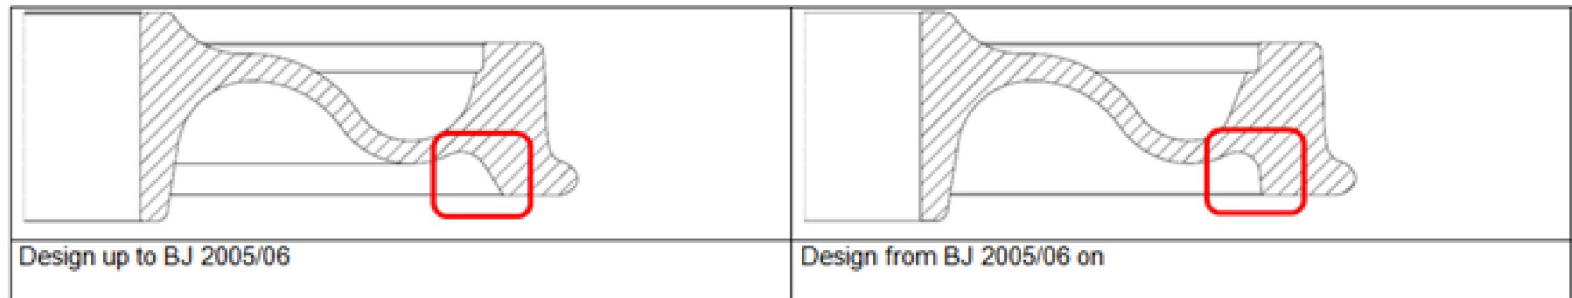
Wheelset type BA 314 / ZDB 29 with a slope under the wheel flange ( probably produced until 2005/2006)

The new version (build after 2006) is **not** affected by relevant failures and can therefore be excluded from the special measures for wheel types BA 314/ ZDB 29.

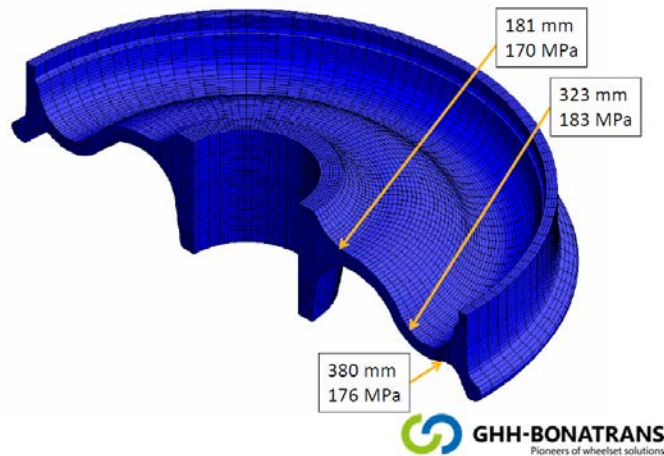
Wheel with slope - old design

- Position of critical point is in web on radius 323 mm on outer side.
- maximal stress amplitude in critical point of wheel web is 183 MPa.
- Stress amplitude in the area of crack (in inner side of web on radius 380 mm) is 176 MPa.

**Conclusion:** Change of design (without slope) reduces stresses in the web and in particular in the area of the crack initiation.

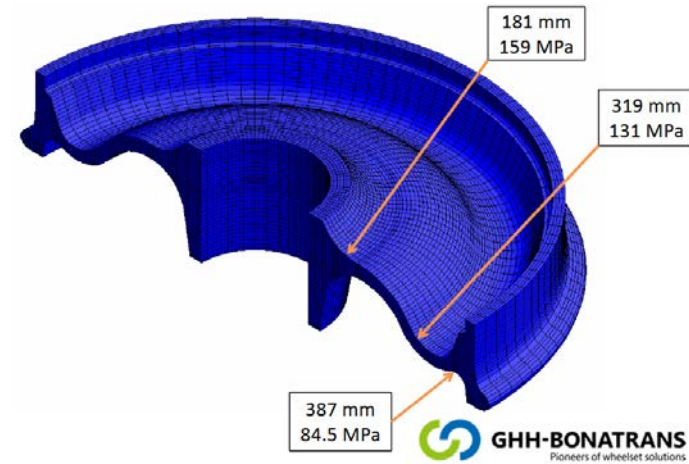
Wheel without slope – new design

- Position of critical point is in transition between hub-web on radius 181 mm.
- maximal stress amplitude in critical point of wheel web is 159 MPa.
- Stress amplitude in the area of crack (in inner side of web on radius 387 mm) is 84.5 MPa.

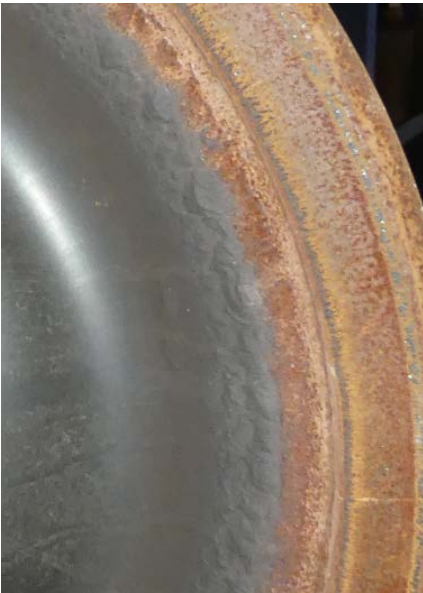
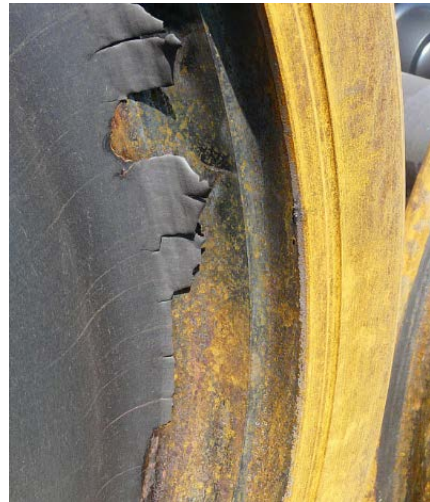
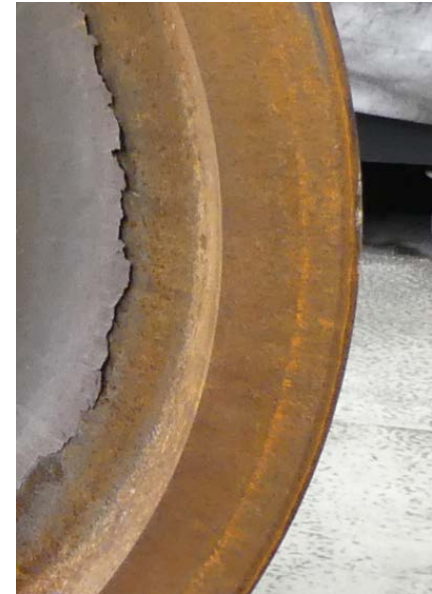
Paint shall be clearly burnt => paint in this area shall present cracks/ peeling / bubbles (no direct dispersion)

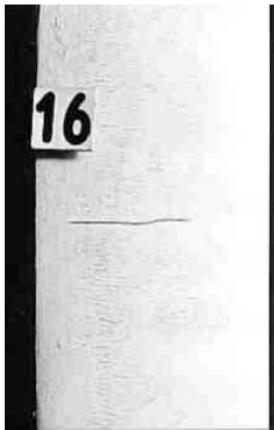
**Description:** The tread exhibits cracks at an angle of approximately 90° to the circumference of the wheel and have a typical length of 30mm or more. Transverse cracks generally develop at the surface in either straight or slightly crooked lines and can penetrate radially (usually of thermal origin in these cases) or branch out in a circumferential direction (usually of mechanical origin in this case). They occur individually and can be distributed at several points around the circumference. [EN 15313, §C.2.6 ]

Transverse crack revealed by magnetic particle testing [EN 15313, §C.2.6 ]

\* single cracks on the wheel tread (“isolated transverse cracking” cf. EN 15313 §C.2.6 and 6.2.3.4) – Criteria: see slide 39

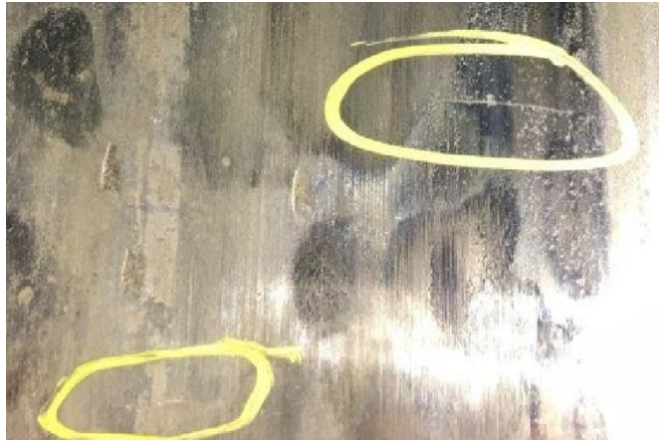
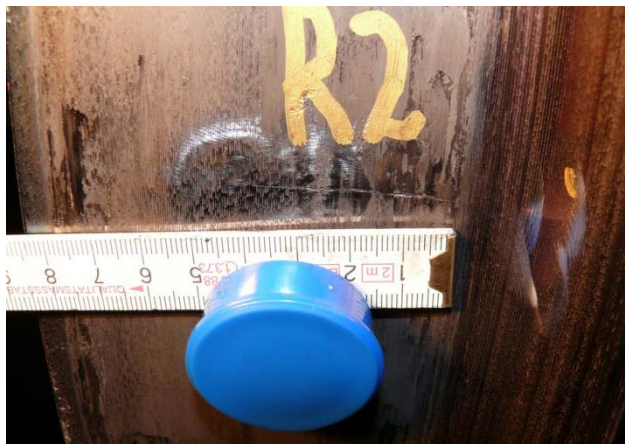
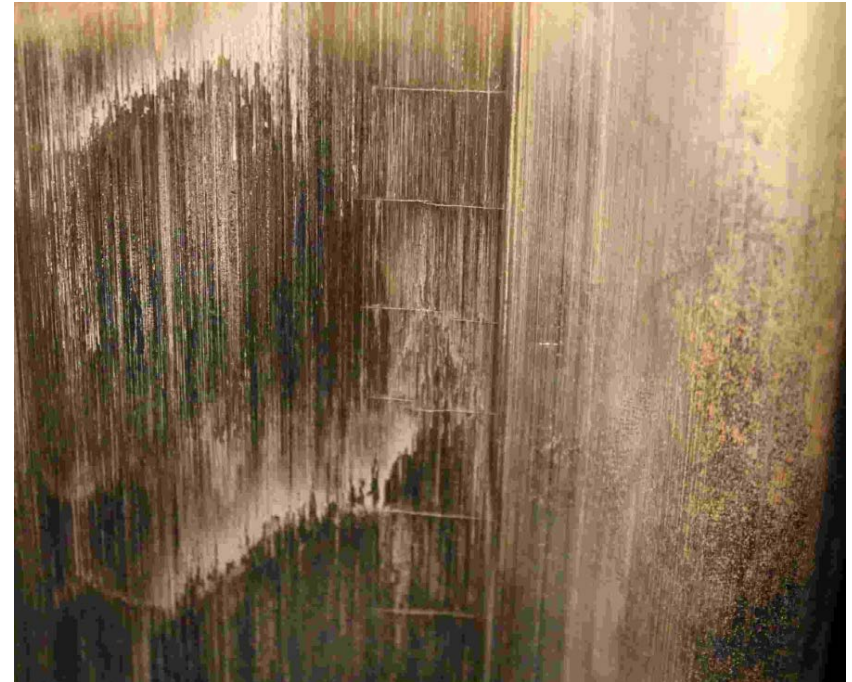
Example for single cracks on the wheel tread by visual inspection

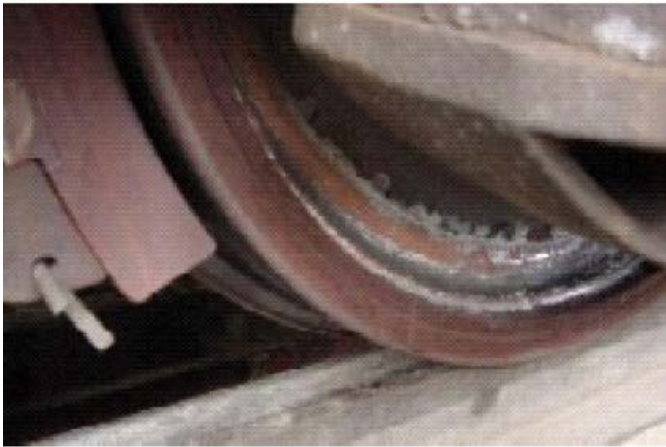
**Description:** This type of defect occurs only in tread-braked wheels. When suitable coatings are used, the paint becomes clearly burnt in the rib/web transition radius when the temperature exceeds approximately 300 °C. The paint in this area then becomes cracked and peeling. The brake blocks are often melted to some extent. Build-up of metal and characteristic colouring can be seen on the tread. The rim may also become a bluish colour.

If the problem is not detected immediately the rim/web transition can gradually assume a rusty appearance with shades between greyish-brown and brown covering the whole circumference. [EN 15313, §C.3.2.2 ]

Overheating affecting the wheel rim/web transition [EN 15313, §C.3.2.2 ]

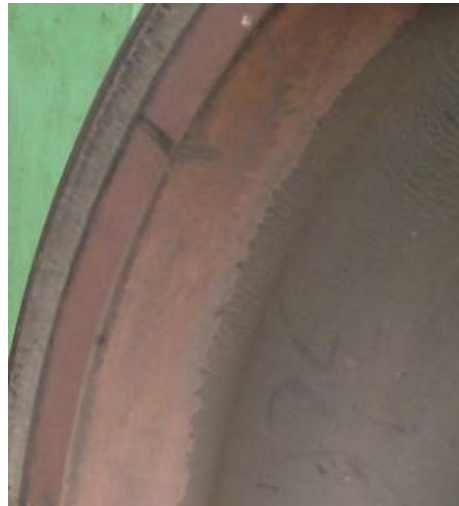
Old and fresh burnt paint

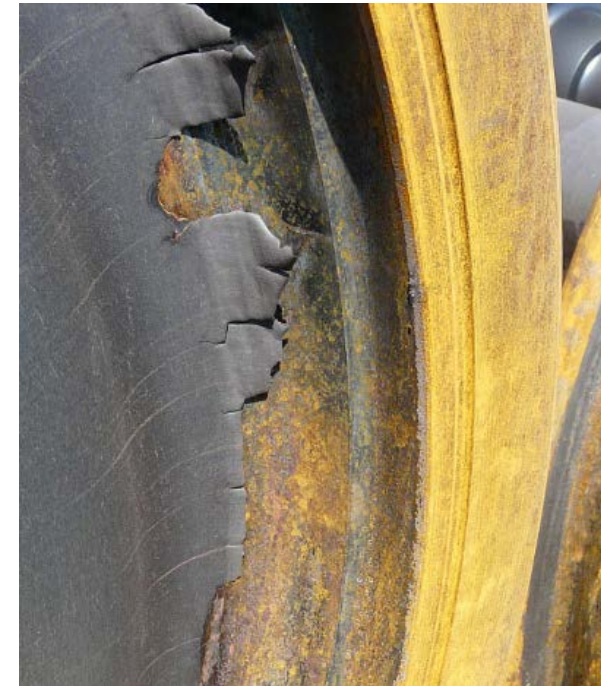
Flanging brake blocks may be an indication of thermal overload.

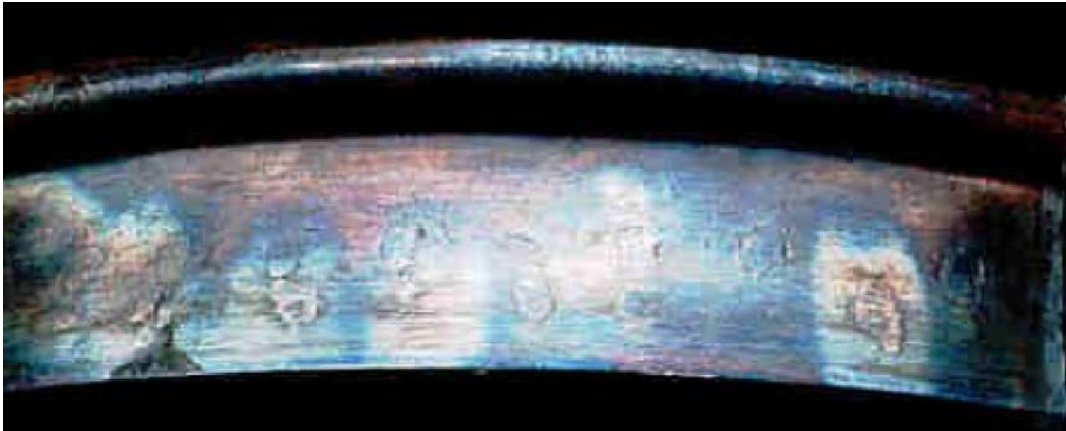
colouring on the tread

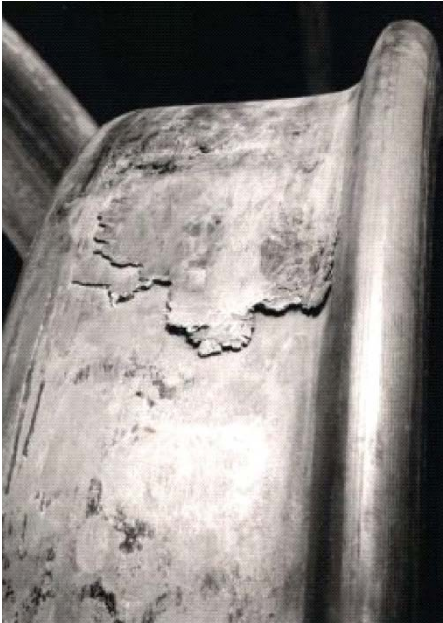
Metal build up on the tread

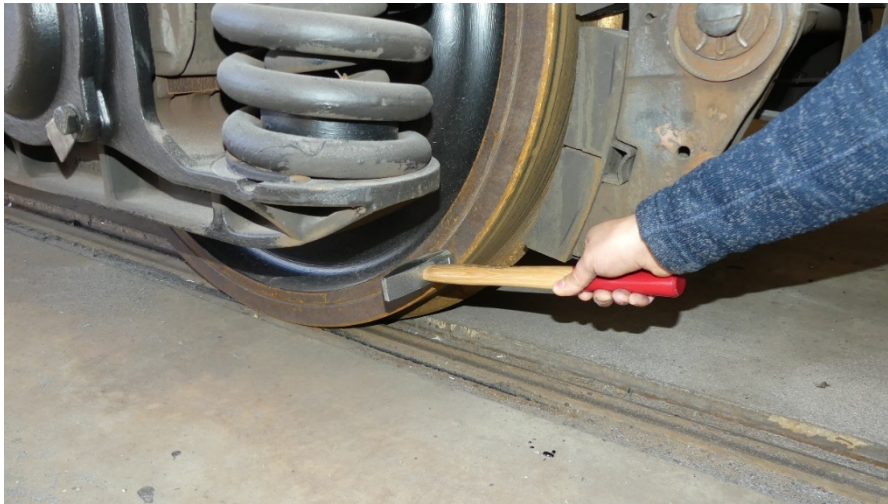
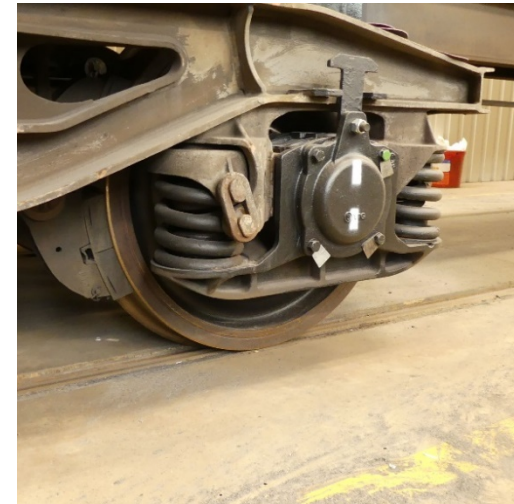
- The test should to be done between 2 and 5 or 7 and 11o' clock around the circumference.
- The test can be done on the tread or the outer sides of the rim.
- The test can be done with a regular hammer with short handle or with a special hammer with long handle for the waggon inspector. For ergonomically reasons a long handle is recommended.

- The test on the 12 o'clock position (upper position of the wheel) sounds always thud/ damped.
- Wheelsets with applied brake blocks or not fully released brake blocks sound also thud/ damped. In this case the full release of the brake blocks has to be checked.
- In case of a thud / damped sounding wheel it is necessary to inspect the whole wheel more carefully.

Hammer/ sound test can be adapted in special cases as additional method to detect cracked rim/ broken wheels.
